Manhole Inspection Summary

Manhole # S43A__001MH

Location Address: **Orleans St**

Cross Street: **Broadway**

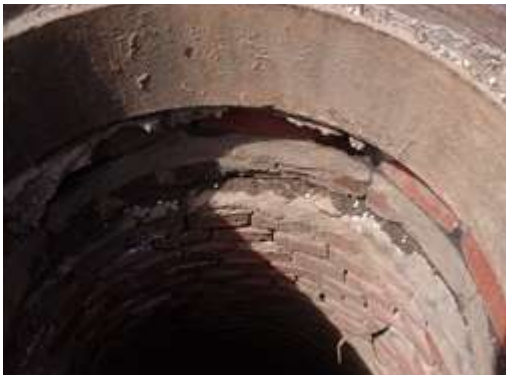
Defect 2

Frame Offset: **2** (in.) Condition: ☐ Sound ☐ Cracked ☒ **Leaks**

Frame Leaks

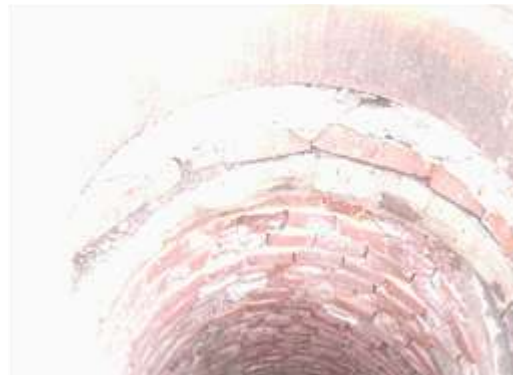
Defect 1

Infiltration: ☐ None ☐ Joint ☐ Cracks ☐ Mortar ☐ Roots ☒ **Wall**

Infiltration

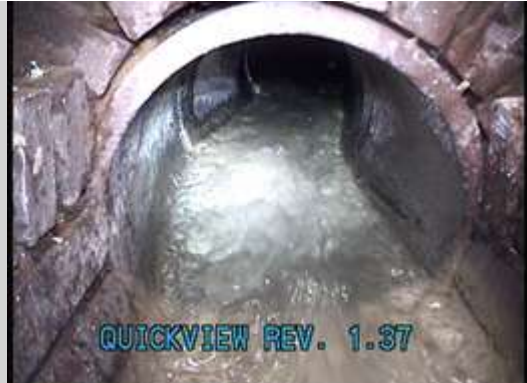
12 O'Clock Outflow

12 in. Circular Gravity Sewer
Pipe Out @ 12 O'Clock

Pipe Height: **12** (in.) Rod and Bar (Angled)
Pipe Material: **Clay** ☐ Pipe Lined
Invert Depth: **12.80** (ft.) Flow Characteristics: **Fast**
Deposits: ☒ None ☐ Mud ☐ Sludge ☐ Debris ☐ Grease
Silt Depth: (in.) Deposits Extent:
Infiltration: **None** Pipe Seal Cond: **Sound**

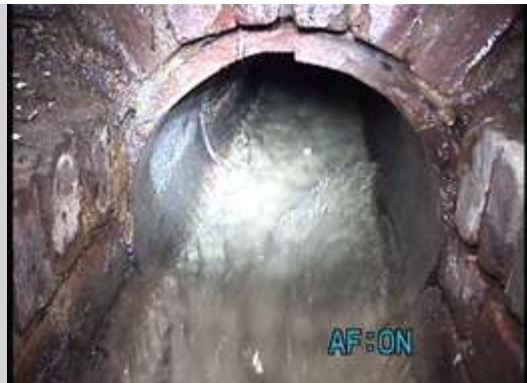
6 O'Clock Inflow

10 in. Circular Gravity Sewer
Pipe In @ 6 O'Clock

Pipe Height: **10.8** (in.) Rod and Bar (Angled)
Pipe Material: **Clay** ☐ Pipe Lined
Invert Depth: **12.70** (ft.) Flow Characteristics: **Fast**
Deposits: ☒ None ☐ Mud ☐ Sludge ☐ Debris ☐ Grease
Silt Depth: (in.) Deposits Extent:
Infiltration: **None** Pipe Seal Cond: **Sound**
